WATER TANK INSPECTION REPORT

JOHNSTOWN, CO

12/12/2023

TANK NAME:	Johnstown 1MMG Tower	LOCATION:	Johnstown, CO
CAPACITY:	1,000,000 gallons	STYLE:	CET
CONSTRUCTION STYLE:	Composite Elevated Tower / Welded	CONSTRUCTION DATE:	N/A
BUILDER:	Landmark Structures	HEIGHT/DIMENSION:	HWL 147' LWL 106' Diameter 70'

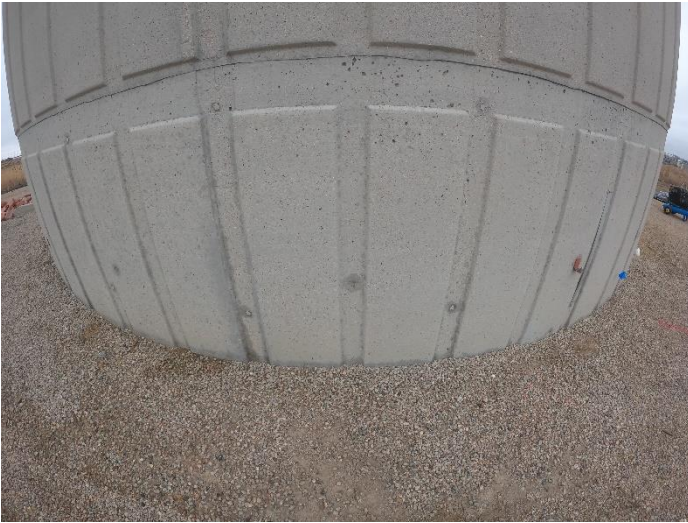
**Exterior Conditions
Excellent Condition.**

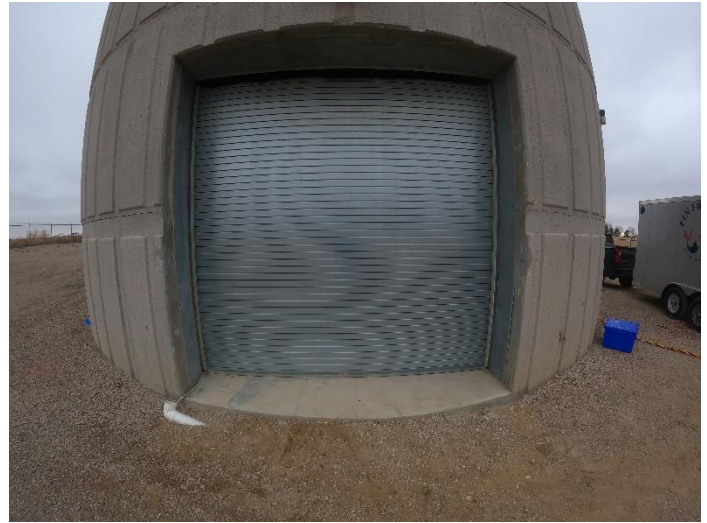
**Exterior Conditions
Excellent Condition, site well maintained and
structure clear of vegetation.**

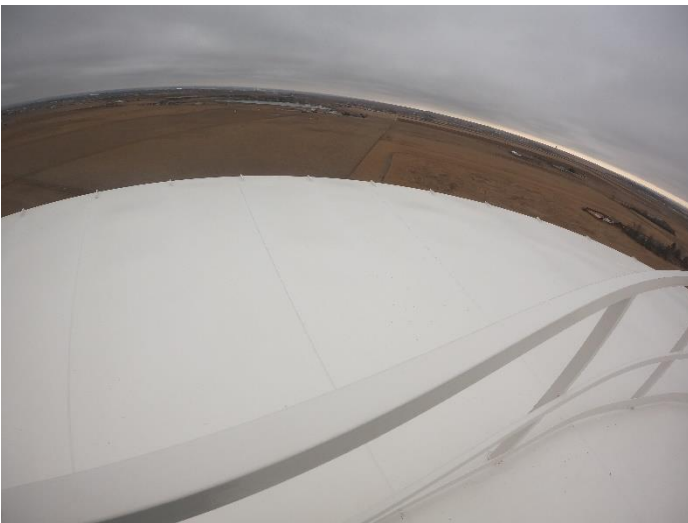
**Exterior Conditions
Good Condition - Coating Protecting Tank**

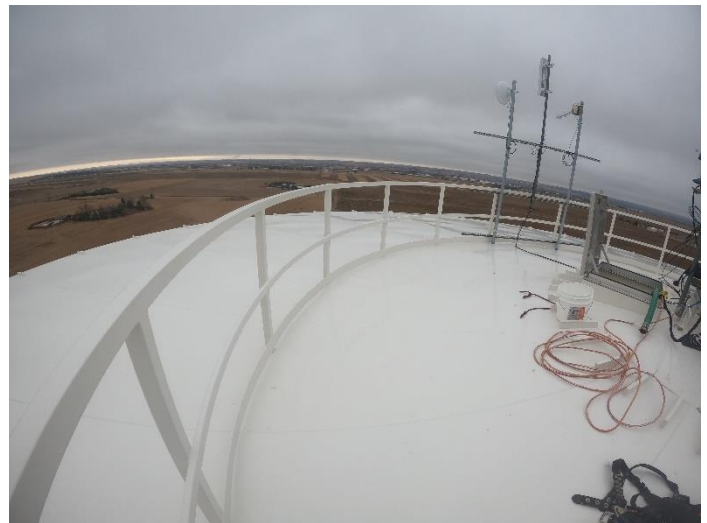
**Exterior Conditions
Good Condition - Coating Protecting Tank**

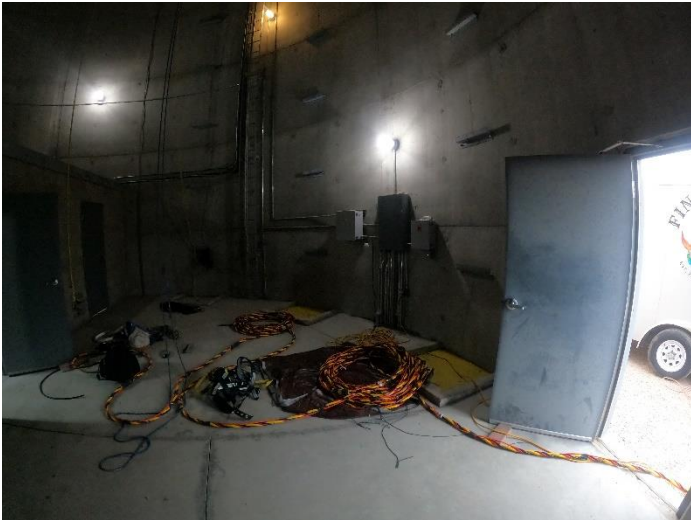
Interior Dry Conditions

Good Condition - Concrete in good condition.

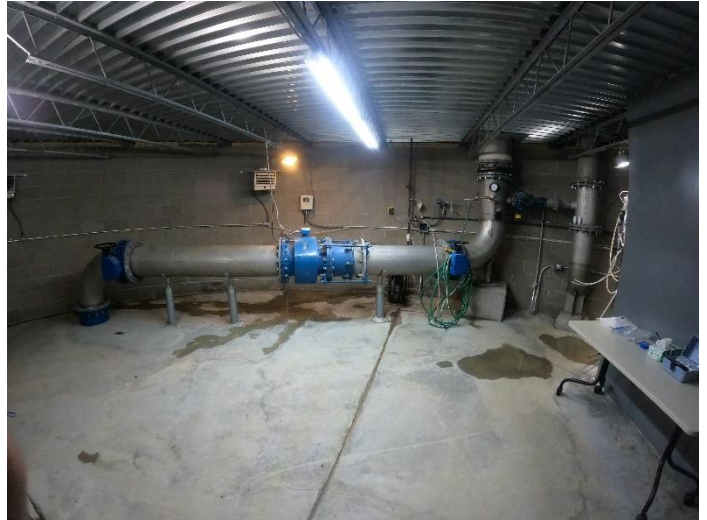
Interior Dry Conditions

Good Condition - Concrete in good condition.

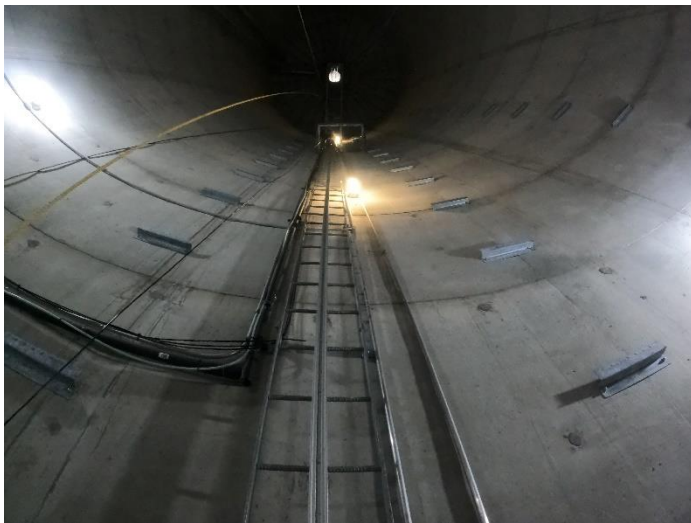
Interior Dry Conditions

Good Condition - Concrete in good condition.

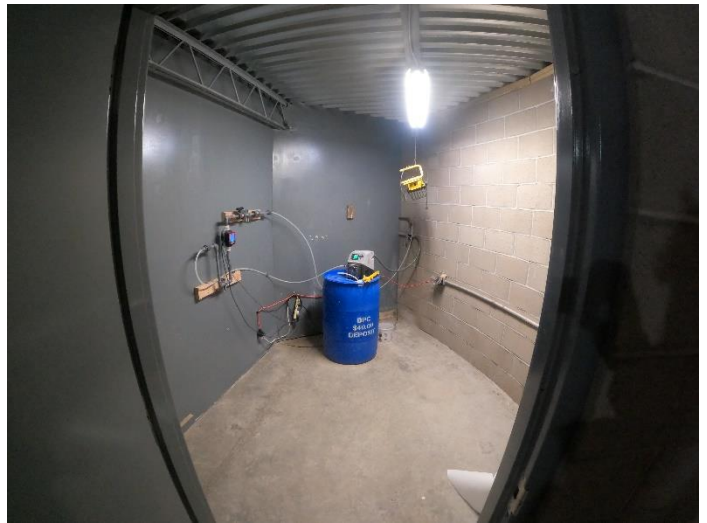
Interior Dry Conditions

Good Condition - Concrete in good condition.

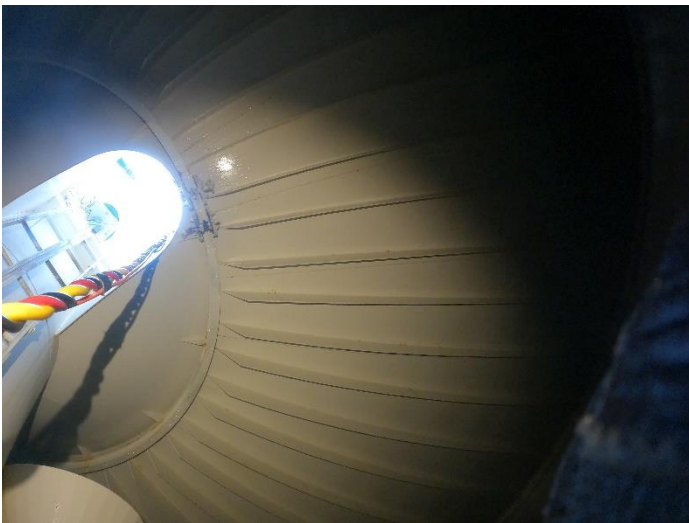
Interior Conditions/Roof Vapor Zone

Good Condition - Coating overall found in good condition and protecting tank.

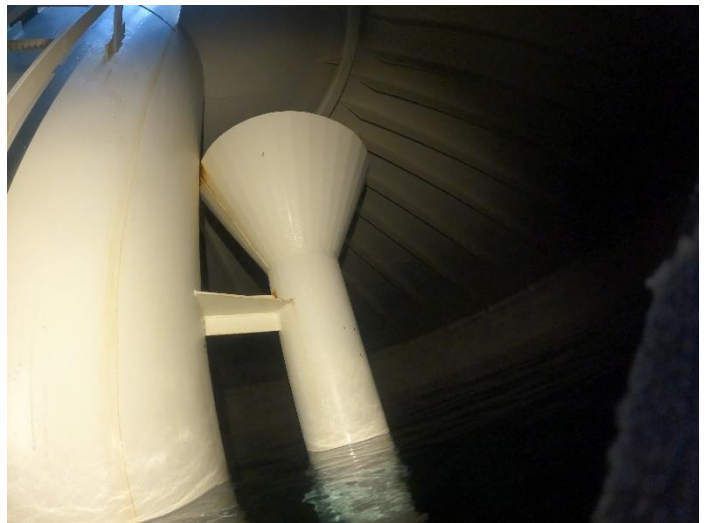
Interior Conditions/Roof Vapor Zone

Good Condition - Coating showing normal signs of age and some areas of failure.

Continue regular inspections and monitoring the interior coating.

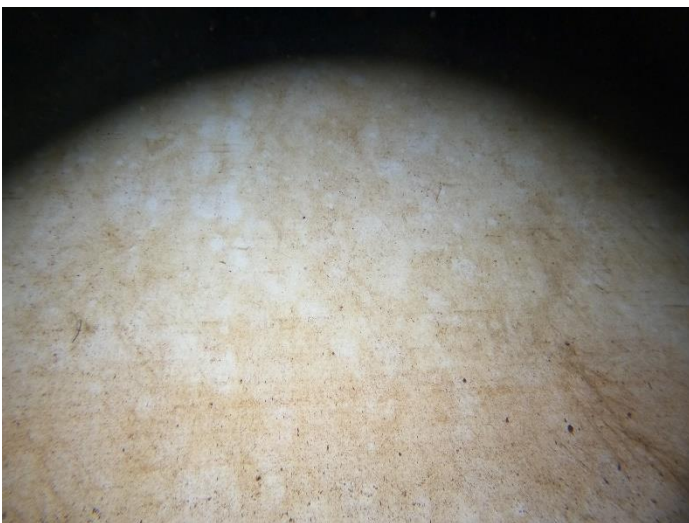
Interior Conditions

Good Condition - Coating showing normal signs of age and some areas of failure, light staining.

Light staining present can be removed via chemical clean which would require the tower be taken out of service. ** Future coatings renovations would require the same, tower taken out of service.

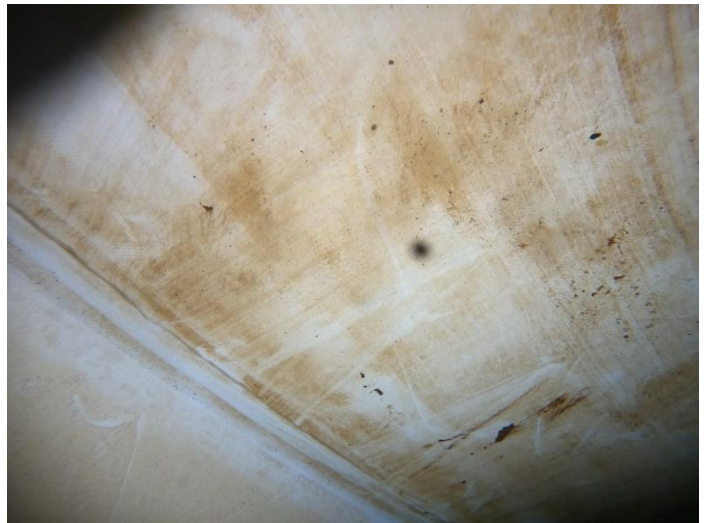
Interior Conditions

Good Condition - Coating showing normal signs of age and some areas of failure. Light staining present wetted area of tank.

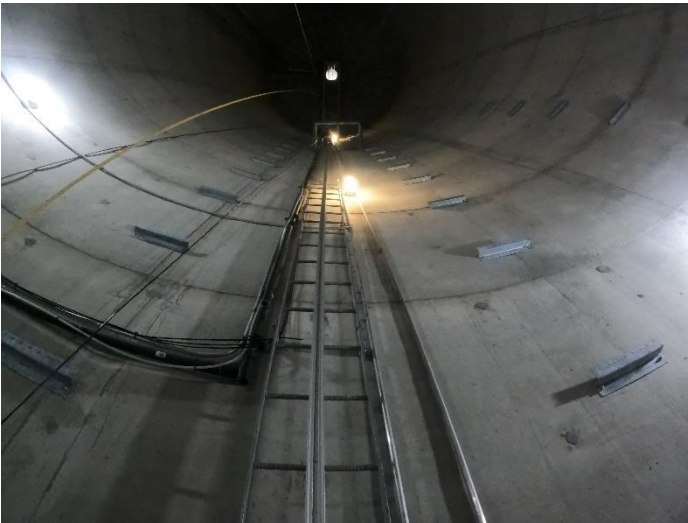
Safety Climb

Rigid Rail safety climb device on ladder(s)

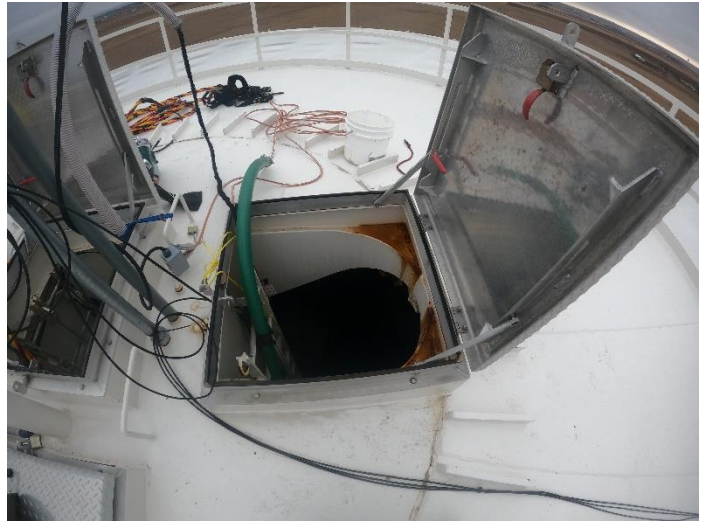
Tank Access

Tank access hatch is proper size and configuration, gasket in place and good condition.

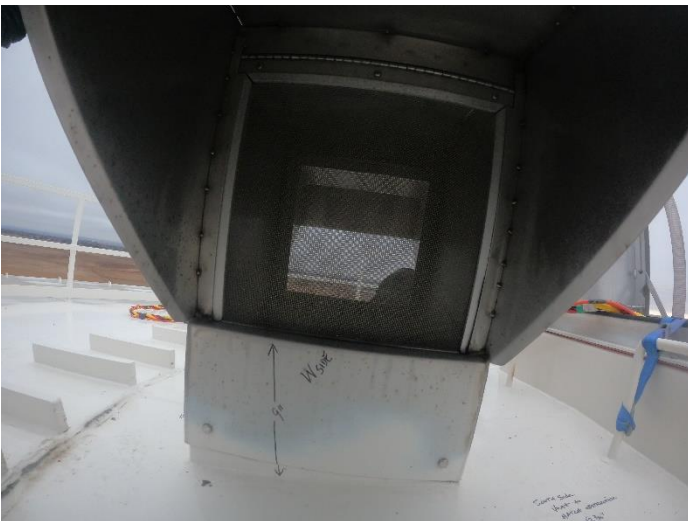
Vent Screen

Vent and screen are in place and in good condition, 24 mesh screen, missing full shroud.

Sanitation items are in compliance with current standards with exception of vent shroud.

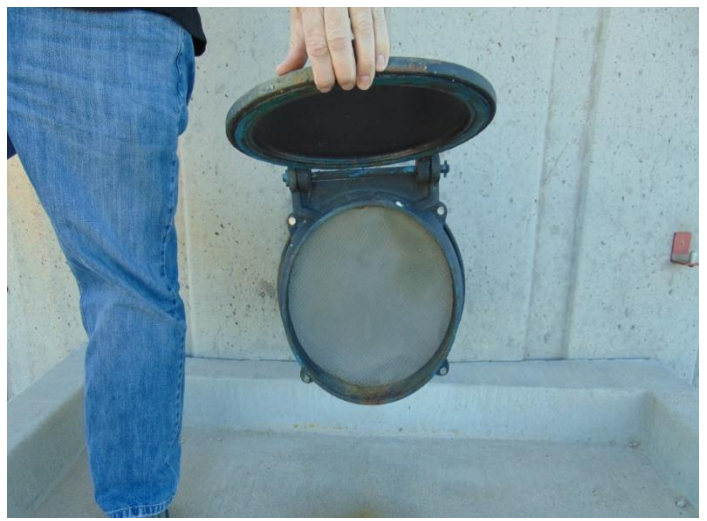
Overflow

Overflow/screen is in good condition and routed to near ground level with flapper in place, splash pad and rip rap

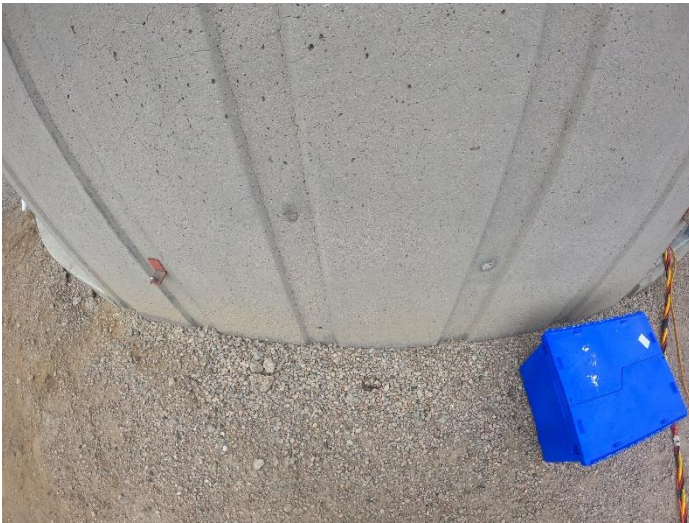
Foundations

Foundation visually appears in good condition.

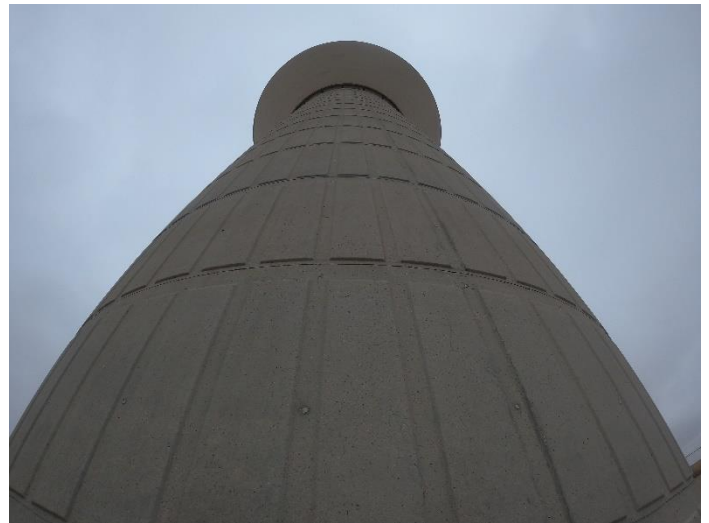
Tower Structure

Tower structural appears to be in good condition.
No visual signs of concern.

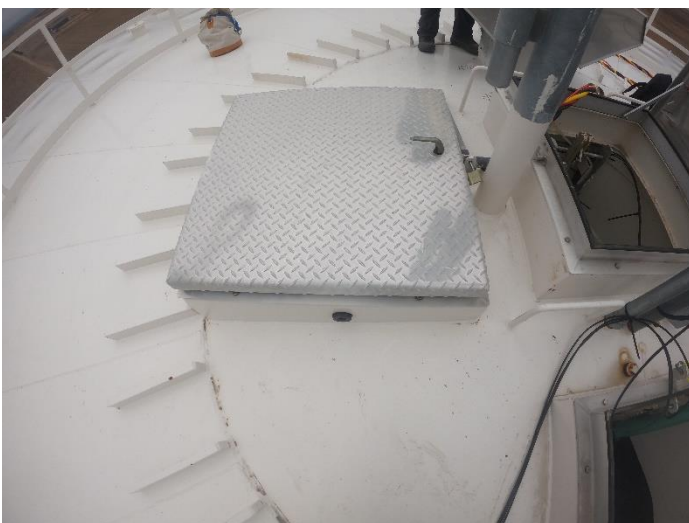
Hatch

Roof hatch was found locked and secured during inspection.

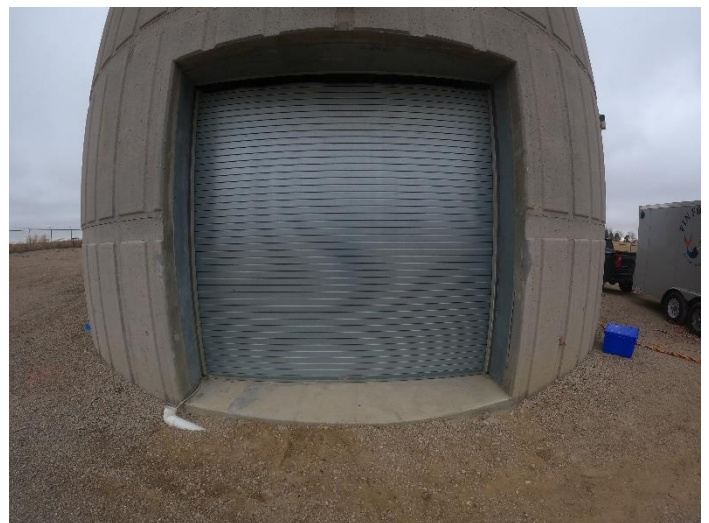
Tower Access

Tower access was locked and secured prior to and post inspection.
